Maps Showing Seismicity Regions

Rapid Visual Screening of Buildings for Potential Seismic Hazards

Rapid Visual Screening of Buildings for Potential Seismic Hazards (FEMA 154)

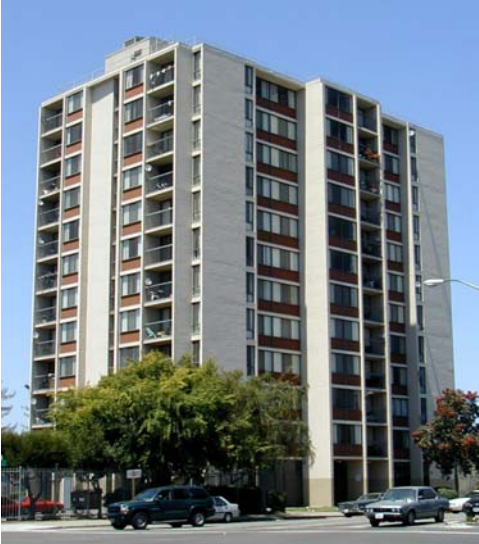
<p>d. 1960-1975 reinforced concrete shear wall</p>

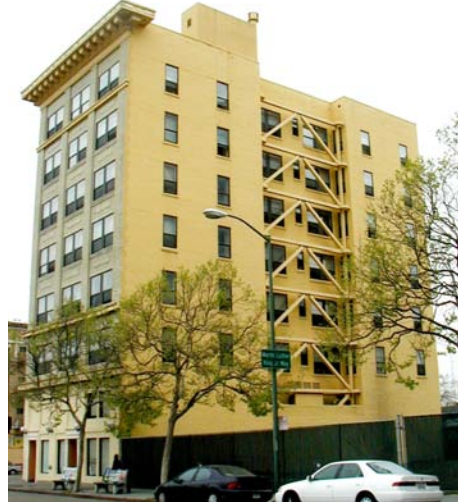
<p>e. Pre-1933 URM (rehabilitated)</p>	<p><u>Low-Rise Buildings (1-3 stories):</u></p> <ul style="list-style-type: none"> • Typically wood or masonry • May have ground floor or basement parking, a soft story • Older buildings typically have more architectural detail, ornamentation • 1950s and later are more 'modern' – lacking ornamentation, typically with more horizontal lines <p>Common structural types: W2, RM1, RM2, URM</p> <p><u>Mid-Rise (4-7 stories) and High-Rise Buildings (8 stories and higher):</u></p> <ul style="list-style-type: none"> • Typically, reinforced concrete (older, URM) • May have commercial ground floor, a soft story • Older buildings typically have more cornices, architectural detail, ornamentation • 1950s and later are lacking ornamentation, typically with stronger vertical or horizontal lines <p>Common structural types: W2, RM1, RM2, URM</p>

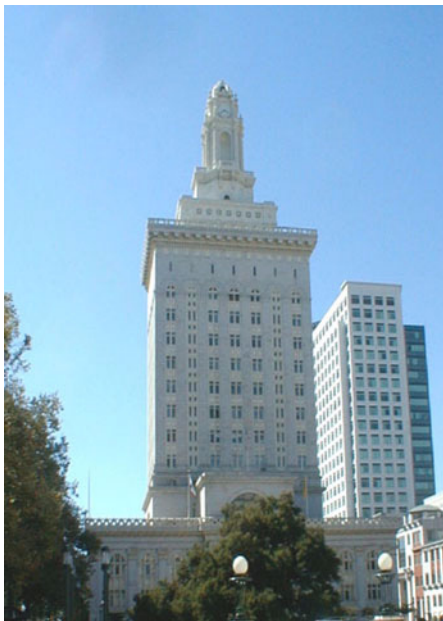
<p>b. 1910-1920 (Steel frame with unreinforced masonry infill that has been seismically rehabilitated)</p> </div> <div data-bbox="196 871 634 1480">

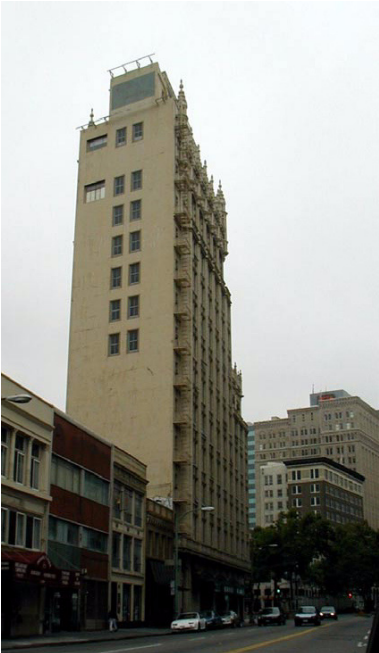
<p>e. 1920-1930; windows create coupled shear walls.</p>

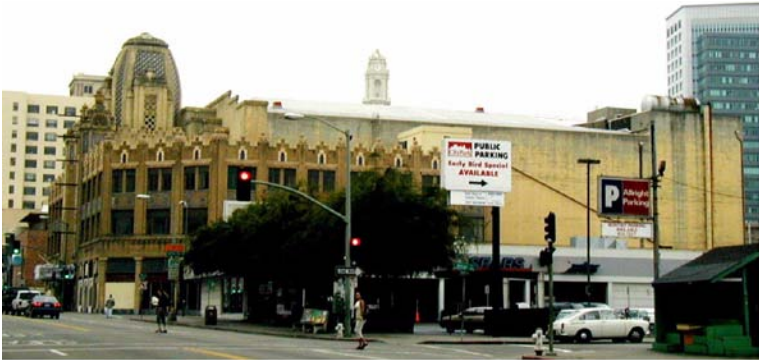
<p>h. 1920-1930; theater and shops complex, reinforced concrete</p>

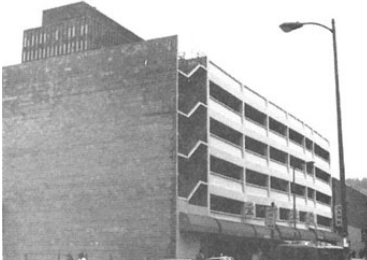
<p>g. 1950 – 1965 parking structure</p>

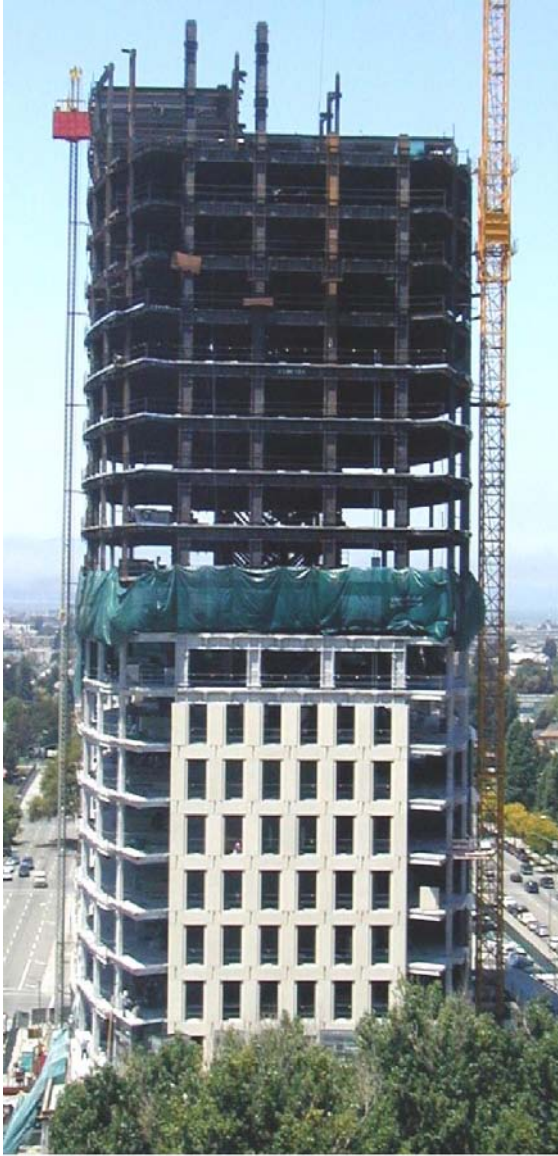
a. Building above is a high-rise steel dual system – moment frame (heavy columns and beams on upper facade) with bracing around elevator core. Fireproofing is being applied to steel at mid-height (inside the shroud) and precast facade elements are being attached to frame in lower stories.

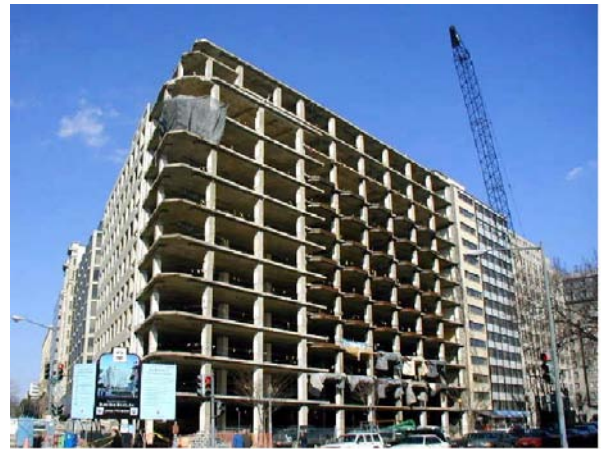
c. New precast facade units being applied to reinforced concrete frame buildings.

Figure D-1 Photos showing basic construction, in steel-frame buildings and reinforced concrete-frame buildings.

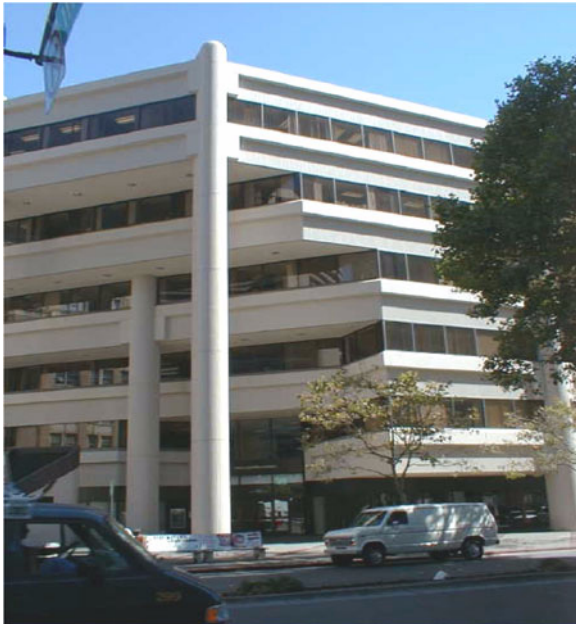
Figure D-2 Building with exterior columns covered with a facade material.

1. In newer frame construction the columns are often exposed on the exterior in the first story. If the columns are covered with a facade material, they are most likely steel columns, indicating a steel frame. If the frames are concrete, they are usually exposed and not covered with a facade. See Figures D-2 and D-3.
2. Some structures use a combination of shear walls in the transverse direction and frames in the longitudinal direction. This can be seen from the exterior as the shear walls usually extend through the exterior longitudinal wall and are exposed there. This is most common in hotels and other residential structures where balconies are included. See Figure D-4.
3. An inspection of doorways and window framing can determine wall thickness. When the thickness exceeds approximately 12 inches, the wall is most likely unreinforced masonry (URM).

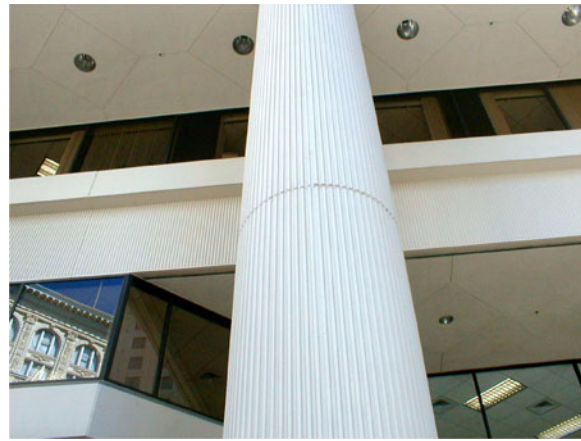
Figure D-3 Detail of the column facade of Figure D-2.

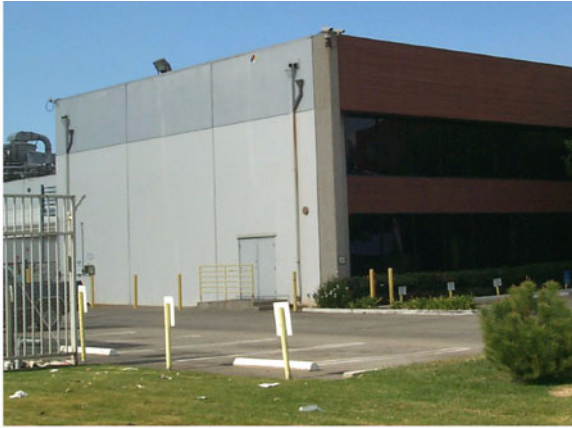
Figure D-5 Regular, full-height joints in a building's wall indicate a concrete tilt-up.

4. If there are vertical joints in the wall, regularly spaced and extending to the full height, the wall is constructed of concrete, and if three or less stories in height, the structure type is most likely a tilt-up (PC1). See Figure D-5.
5. If the building is constructed of brick masonry without header courses (horizontal rows of visible brick ends), and the wall thickness is approx-

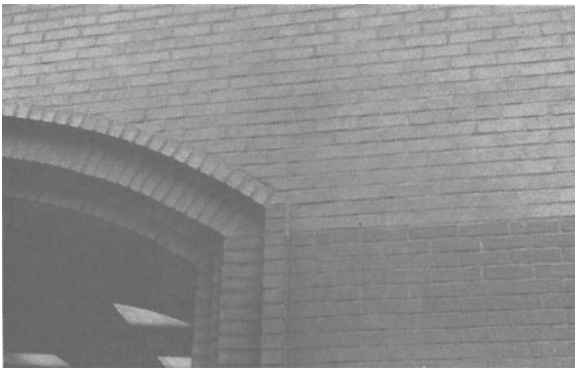
Figure D-6 Reinforced masonry wall showing no course of header bricks (a row of visible brick ends).

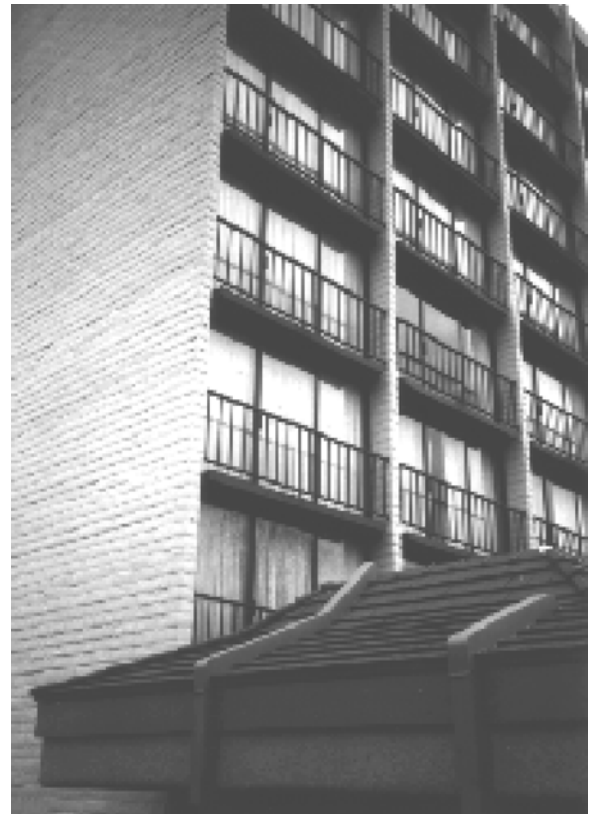
Figure D-7 Reinforced masonry building with exterior wall of concrete masonry units, or concrete blocks.

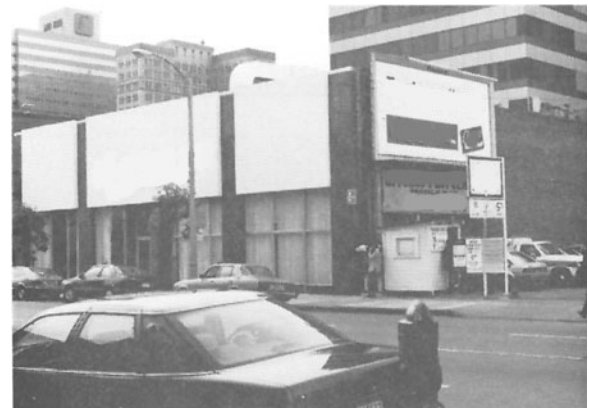
Figure D-8 A 1970s renovated facade hides a URM bearing-wall structure.

Because many buildings have been renovated, the screener should know where to look for clues to the original construction. Most renovations are done for commercial retail spaces, as businesses like to have an up-to-date image. Most exterior renovations are only to the front of the building or to walls that attract attention. Therefore, the original construction

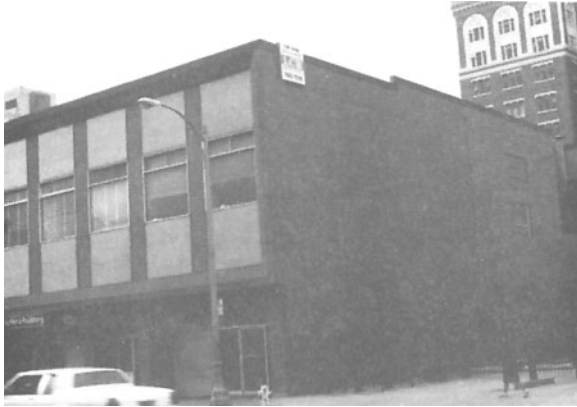
Figure D-9 A concrete shear-wall structure with a 1960s renovated facade.

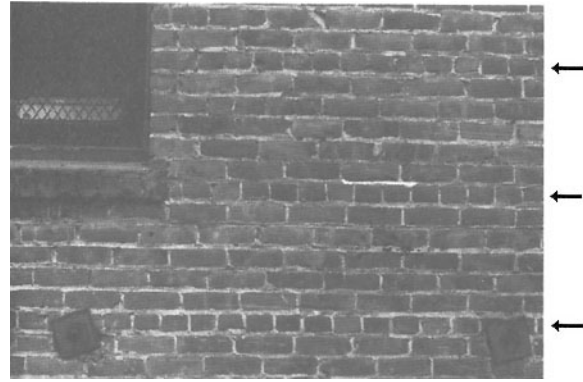
Figure D-10 URM wall showing header courses (identified by arrows) and two washer plates indicating wall anchors.

- **Unreinforced Masonry**—Unreinforced masonry walls, when they are not veneers, are typically several wythes thick (a wythe is a term denoting the width of one brick). Therefore, header bricks will be apparent in the exposed surface. Headers are bricks laid with the butt end on the exterior face, and function to tie wythes of bricks together. Header courses typically occur every six or seven courses. (See Figures D-10 and D-11.) Sometimes, URM infill walls will not have header bricks, and the wythes of brick are held together only by mortar. Needless to say, URM will look old, and most of the time show wear and weathering. URM may also have a soft sand-lime mortar which may be detected by scratching with a knife, unless the masonry has been repointed.

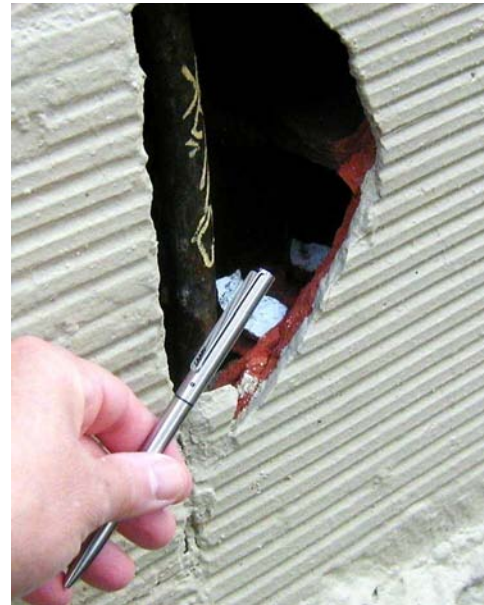
Figure D-14 Hollow clay tile wall with punctured tile.

- **Hollow Clay Tile**—The exposed area of a hollow clay tile masonry unit is approximately 6 inches by 10 inches and often has strip indentations running the length of the tile. They are fragile, unreinforced, and without structural value, and usually are used for non-load-bearing walls.

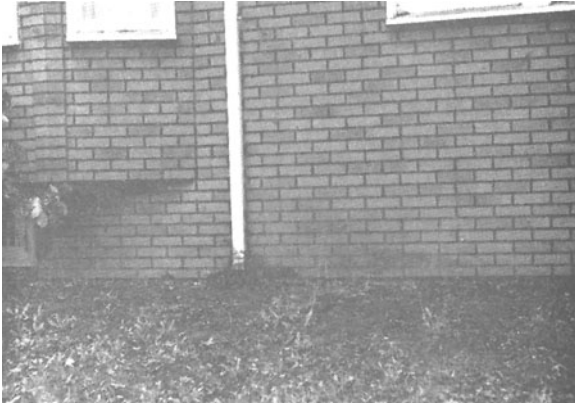
Figure D-16 Asphalt siding with brick pattern.

- **False Masonry**—Masonry pattern sidings can be made from sheet metal, plastic, or asphalt material (see Figures D-15 and D-16). These sidings come in sheets and are attached to a structural backing, usually a wood frame. These sidings can be detected by looking at the edges and by their sound when tapped.
- **Cast-in-Place Concrete**—Cast-in-place concrete, before the 1940s, will likely show horizontal patterns from the wooden formwork. The formwork was constructed with wood planks, and therefore the concrete also will often show the wood grain pattern. Since the plank edges were not smooth,

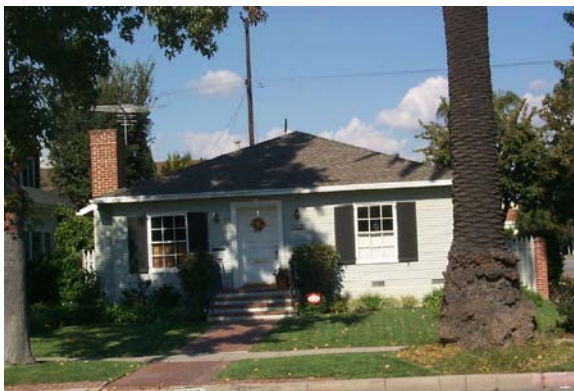
Figure E-1 Single family residence (an example of the W1 identifier, light wood-frame residential and commercial buildings less than 5000 square feet).

Wood frame structures are usually detached residential dwellings, small apartments, commercial buildings or one-story industrial structures. They are rarely more than three stories tall, although older buildings may be as high as six stories, in rare instances. (See Figures E-1 and E-2)

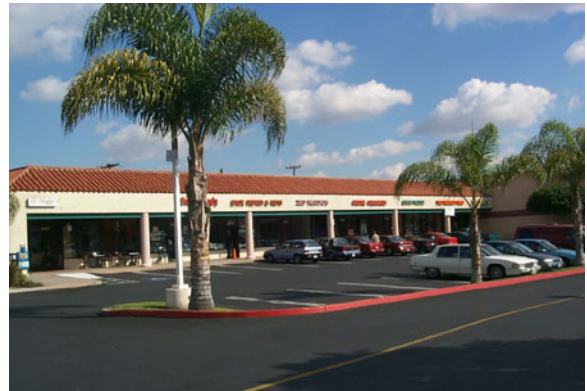
Figure E-2 Larger wood-framed structure, typically with room-width spans (W2, light, wood-frame buildings greater than 5000 square feet).

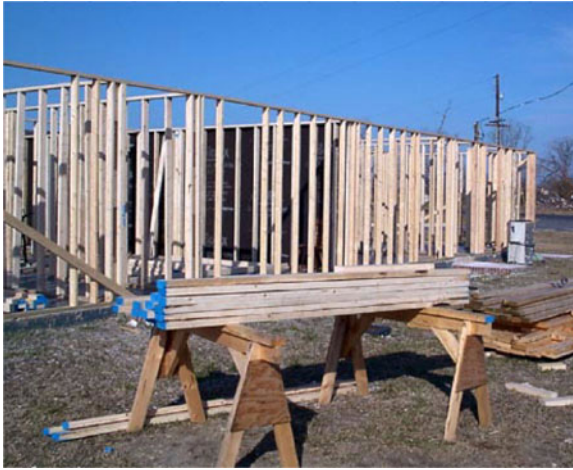
Figure E-4 Stud wall, wood-framed house.

Wood stud walls are typically constructed of 2-inch by 4-inch wood members vertically set about 16 inches apart. (See Figures E-3 and E-4). These walls are braced by plywood or equivalent material, or by diagonals made of wood or steel. Many detached single family and low-rise multiple family residences in the United States are of stud wall wood frame construction.

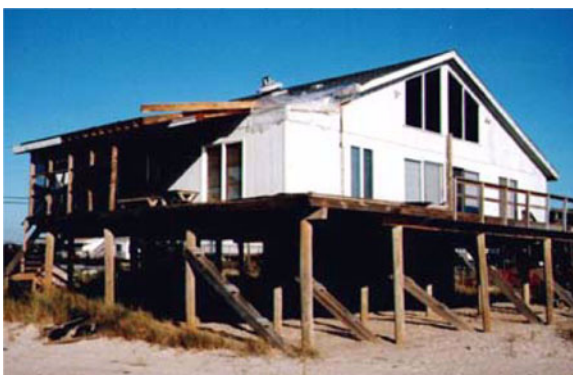
Figure E-6 Timber pole framed house.

Timber pole buildings (Figures E-5 and E-6) are a less common form of construction found mostly in suburban and rural areas. Generally adequate seismically when first built, they are more often subject to wood deterioration due to the exposure of the columns, particularly near the ground surface. Together with an often-found “soft story” in this building type, this deterioration may contribute to unsatisfactory seismic performance.

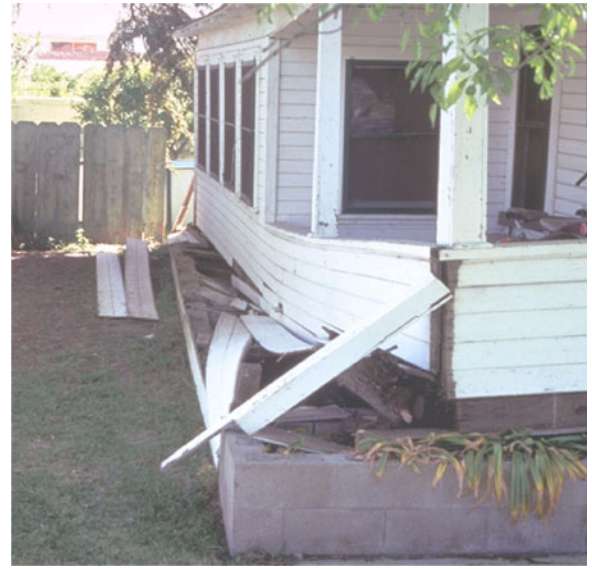
Figure E-7 House off its foundation, 1983 Coalinga earthquake.

type of damage helps dissipate the earthquake-induced energy of the shaking house. The most common type of structural damage in older buildings results from a lack of adequate connection between the house and the foundation. Houses can slide off their foundations if they are not properly bolted to the foundations. This movement (see Figure E-7) results in major damage to the building as well as to plumbing and electrical connections. Overturning of

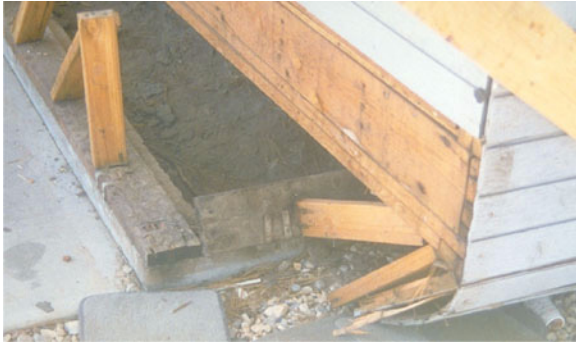
Figure E-8 Failed cripple stud wall, 1992 Big Bear earthquake.

Another problem in older buildings is the stability of cripple walls. Cripple walls are short stud walls between the foundation and the first floor level. Often these have no bracing neither in-plane nor out-of-plane and thus may collapse when subjected to horizontal earthquake loading. If the cripple walls collapse, the house will sustain considerable damage and may collapse. In some older homes, plywood sheathing nailed to the cripple studs may have been used to rehabilitate the cripple walls. However, if the sheathing is not nailed adequately to the studs and

foundation sill plate, the cripple walls will still collapse (see Figure E-8).

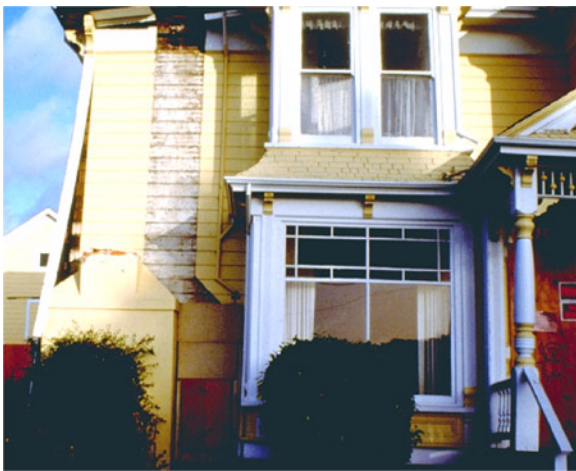
Figure E-9 Failure of post and pier foundation, Humboldt County.

Homes with post and pier perimeter foundations, which are constructed to provide adequate air flow under the structure to minimize the potential for decay, have little resistance to earthquake forces. When these buildings are subjected to strong earthquake ground motions, the posts may rotate or slip of the piers and the home will settle to the ground. As with collapsed cripple walls, this can be very expensive damage to repair and will result in the home building “red-tagged” per the ATC-20 post-earthquake safety evaluation procedures (ATC, 1989, 1995). See Figure E-9.

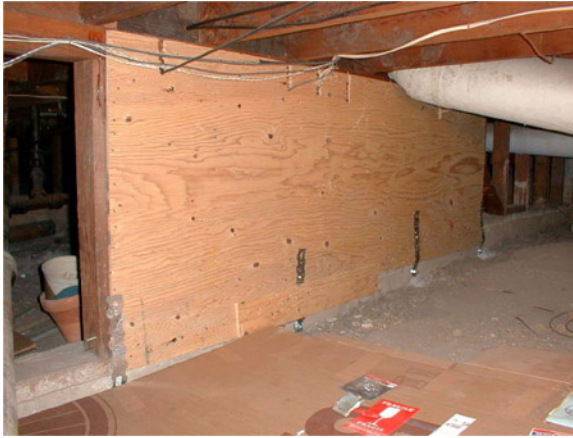
Figure E-10 Seismic strengthening of a cripple wall, with plywood sheathing.

The rehabilitation techniques focus on houses with continuous perimeter foundations and cripple walls. The rehabilitation work consists of bolting the house to the foundation and providing plywood or other wood sheathing materials to the cripple walls to strengthen them (see Figure E-10). This is the most cost-effective rehabilitation work that can be done on a single-family residence.

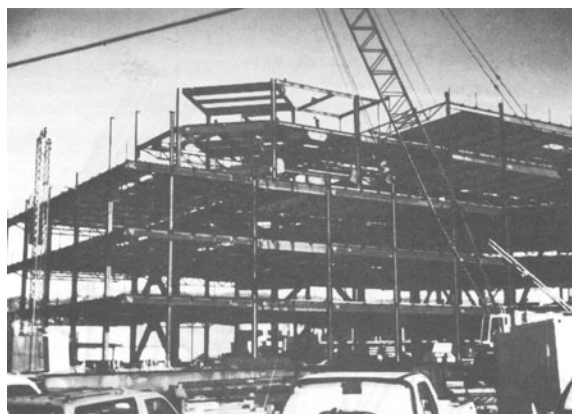
Figure E-13 Braced steel frame, with chevron and diagonal braces. The braces and steel frames are usually covered by finish material after the steel is erected.

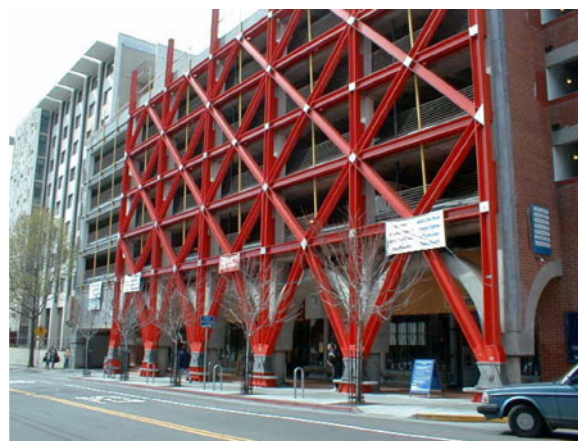
Figure E-15 Rehabilitation of a concrete parking structure using exterior X-braced steel frames.

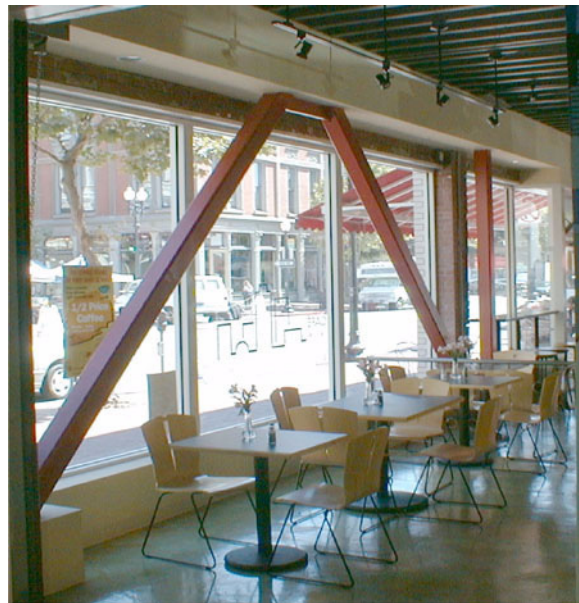
Figure E-16 Use of a braced frame to rehabilitate an unreinforced masonry building.

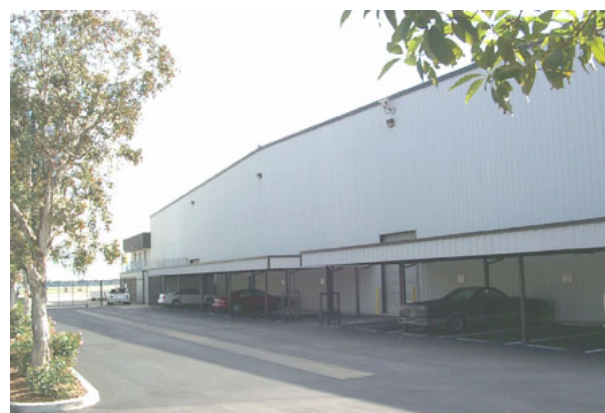
Figure E-19 Prefabricated metal building (S3, light metal building).

3. These buildings generally have only a few windows, as it is difficult to detail a window in the sheet metal system.
4. The screener should look for signs of a metal building, and should knock on the siding to see if it sounds hollow. Door openings should be inspected for exposed steel members. If a gap, or light, can be seen where the siding meets the ground, it is certainly light metal or wood frame. For the best indication, an interior inspection will confirm the structural skeleton, because most of these buildings do not have interior finishes.

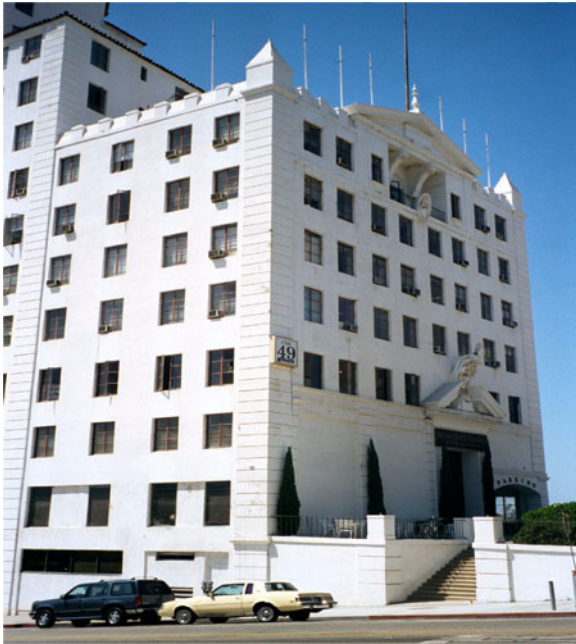
Figure E-21 Concrete shear wall on building exterior.

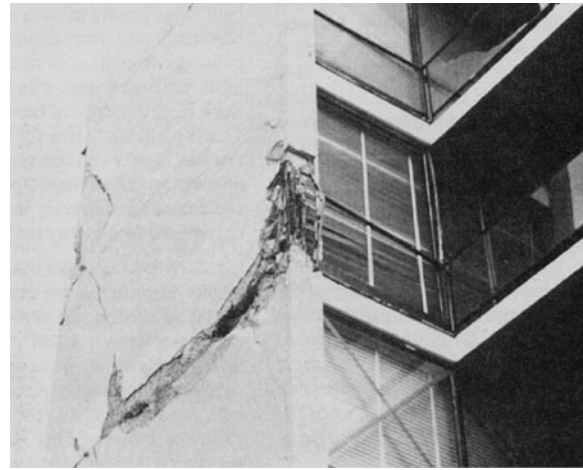
Figure E-22 Close-up of exterior shear wall damage during a major earthquake.

It is often difficult to differentiate visually between a steel frame with concrete shear walls and one without, because interior shear walls will often be covered by interior finishes and will look like interior nonstructural partitions. For the purposes of an RVS, unless the shear wall is identifiable from the exterior (i.e., a raw concrete finish was part of the architectural aesthetic of the building, and was left exposed), this building cannot be identified accurately. Figure E-21 shows a structure with such an exposed shear wall. Figure E-22 is a close-up of shear wall damage.

1. Shear cracking and distress can occur around openings in concrete shear walls.

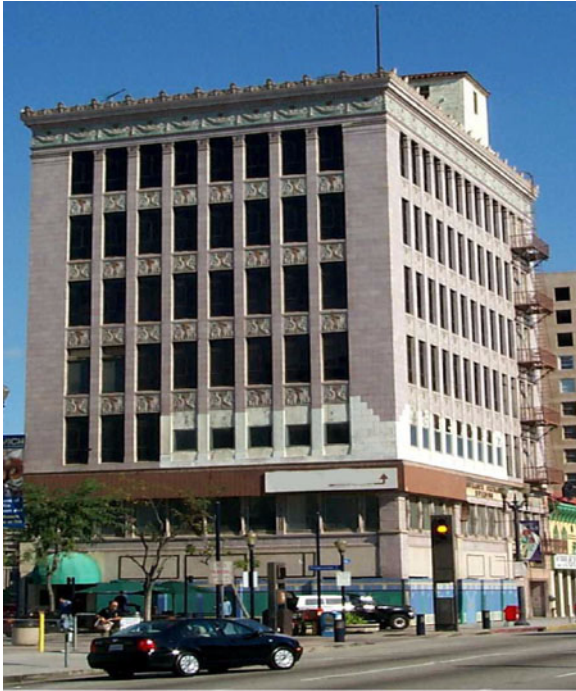
Figure E-24 Example of steel frame with URM infill walls (S5).

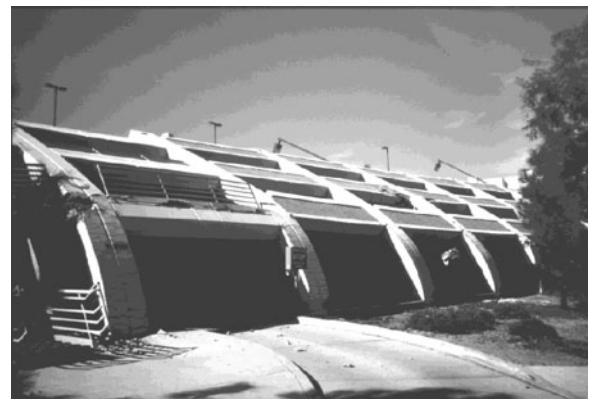
Figure E-26 Extreme example of ductility in concrete, 1994 Northridge earthquake.

Ductile detailing refers to the presence of special steel reinforcing within concrete beams and columns. The special reinforcement provides confinement of the concrete, permitting good performance in the members beyond the elastic capacity, primarily in bending. Due to this confinement, disintegration of the concrete is delayed, and the concrete retains its strength for more cycles of loading (i.e., the ductility is increased). See Figure E-26 for a dramatic example of ductility in concrete.

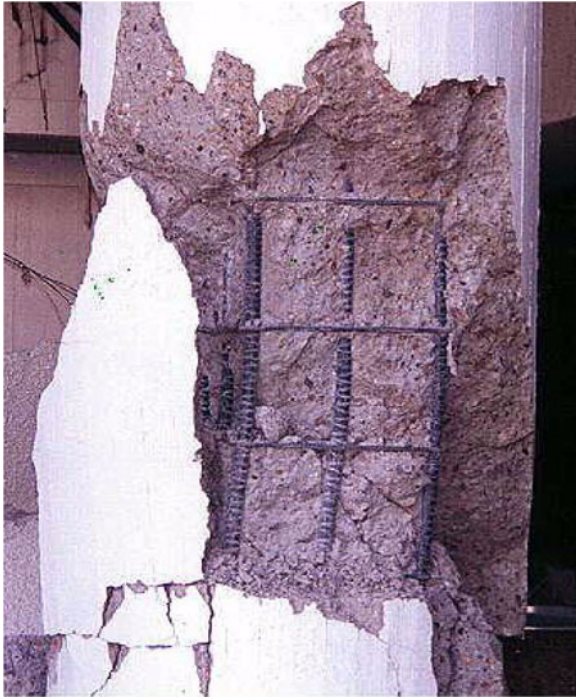
Figure E-27 Example of ductile reinforced concrete column, 1994 Northridge earthquake; horizontal ties would need to be closer for greater demands.

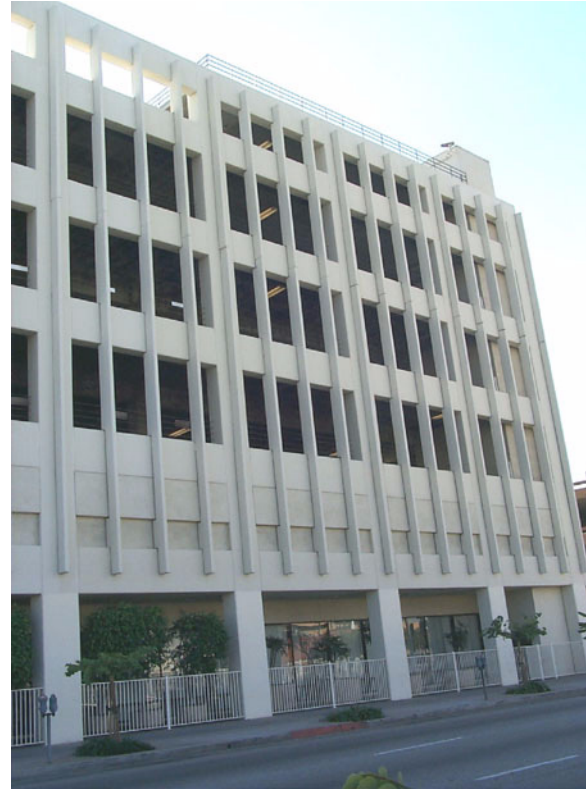
Figure E-28 Concrete moment-resisting frame building (C1) with exposed concrete, deep beams, wide columns (and with architectural window framing).

This building type is difficult to differentiate from steel moment-resisting frames unless the structural concrete has been left relatively exposed (see Figure E-28). Although a steel frame may be encased in concrete and appear to be a concrete frame, this is seldom the case for modern buildings (post 1940s). For the purpose of the RVS procedures, it can be assumed that all exposed concrete frames are concrete and not steel frames.

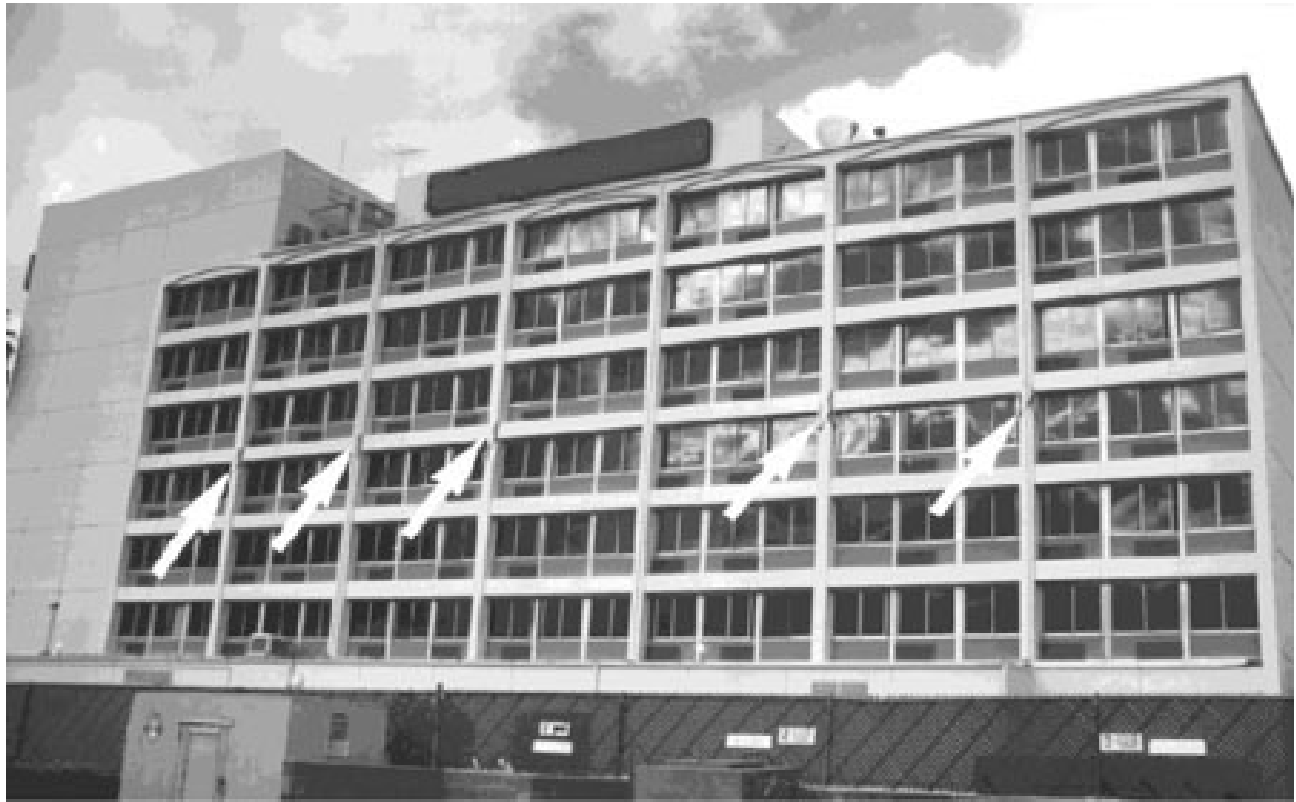
Figure E-29 Locations of failures at beam-to-column joints in nonductile frames, 1994 Northridge earthquake.

Under high amplitude cyclic loading, lack of confinement will result in rapid disintegration of non-ductile concrete members, with ensuing brittle failure and possible building collapse (see Figure E-29).

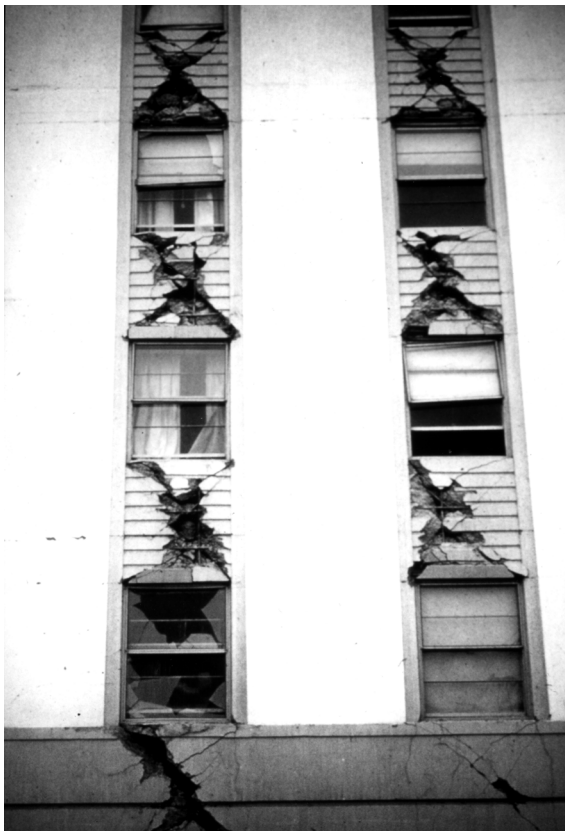
Figure E-31 Tall concrete shear-wall building: walls connected by damaged spandrel beams.

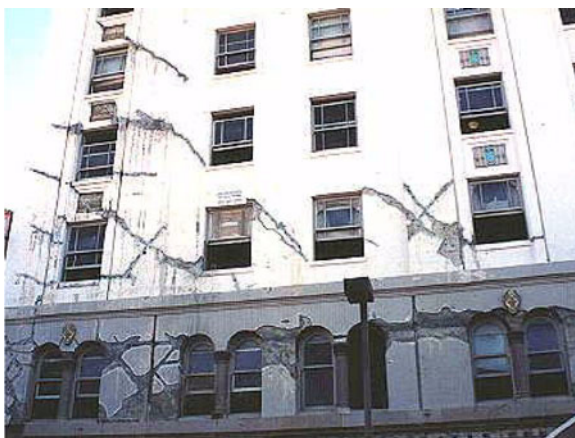
Figure E-32 Shear-wall damage, 1989 Loma Prieta earthquake.

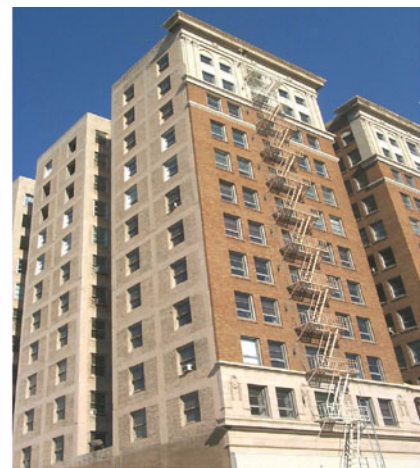
Figure E-34 Blow-up (lower photo) of distant view of C3 building (upper photo) showing concrete frame with URM infill (left wall), and face brick (right wall).

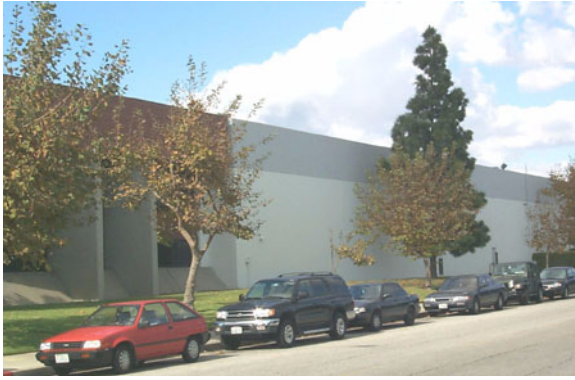
Figure E-36 Tilt-up industrial building, 1970s.

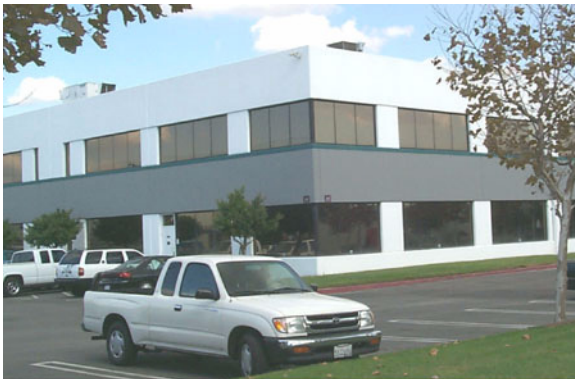
Figure E-37 Tilt-up industrial building, mid- to late 1980s.

and then tilted upward into their final positions. More recently, wall panels are fabricated off-site and trucked to the site.

The major defect in existing tilt-ups is a lack of positive anchorage between wall and diaphragm, which has been corrected since about 1973 in the western United States.

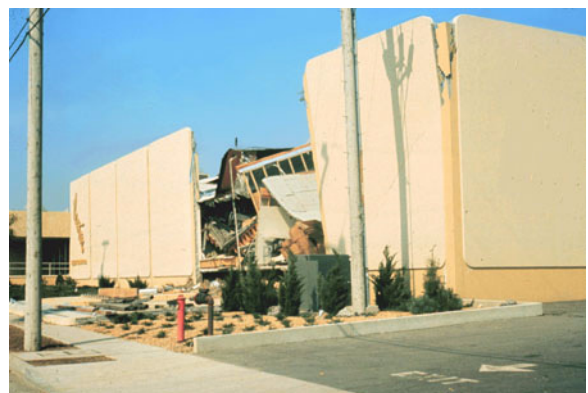
Figure E-39 Result of failure of the roof beam anchorage to the wall in tilt-up building.

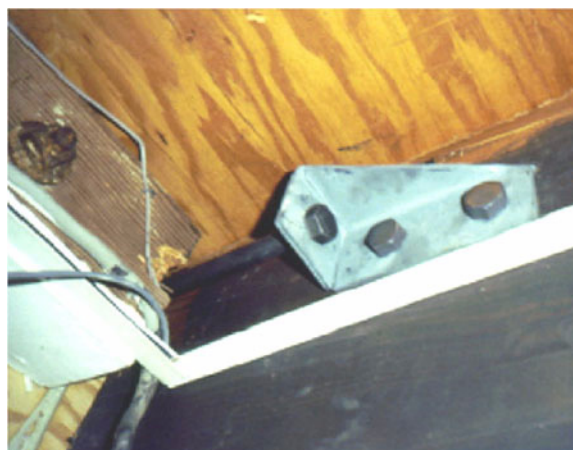
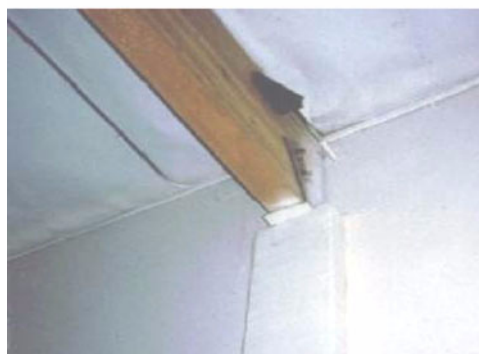
Figure E-40 Newly installed anchorage of roof beam to wall in tilt-up building.

Fernando, California, earthquake. Since 1973, tilt-up construction practices have changed in California and other high-seismicity regions, requiring positive wall-diaphragm connection. (Such requirements may not have yet been made in other regions of the country.) However, a large number of these older, pre-1970s-vintage tilt-up buildings still exist and have not been rehabilitated to correct this wall-anchor defect. Damage to these buildings was observed again in the 1987 Whittier, California, earthquake, 1989 Loma Prieta, California earthquake, and the 1994 Northridge, California, earthquake. These buildings are a prime source of seismic hazard.

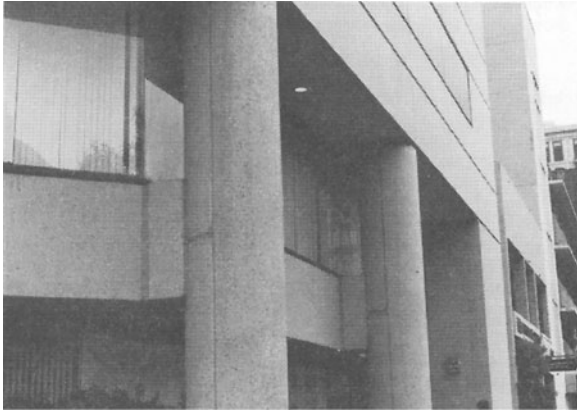
Figure E-42 Typical precast column cover on a steel or concrete moment frame.

- b. Cross or T-shaped units of partial columns and beams — These are structural units for constructing moment-resisting frames. They are usually joined together by field welding of steel connectors cast into the concrete. Joints should be clearly visible at the mid-span of the beams or the mid-height of the columns. See Figure E-45.
- c. Precast arches—Precast arches and pedestals are popular in the architecture of these buildings.
- d. Column—When a column displays a precast finish without an indication that it has a cover (i.e.,

no vertical seam can be found), the column is likely to be a precast structural column.

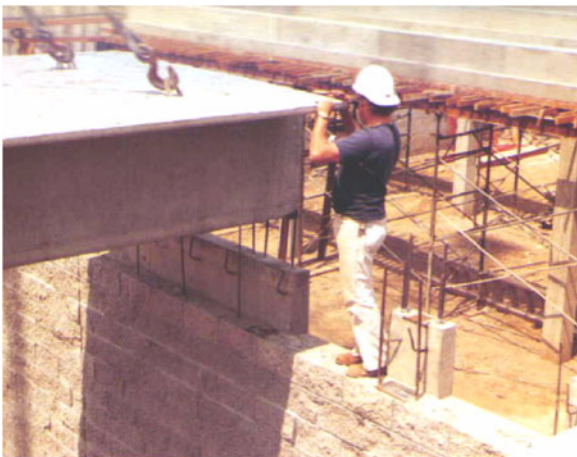
Figure E-44 Example of precast double-T section during installation.

(Figure E-44 shows one end of a double-T beam as it is lowered onto its seat.)

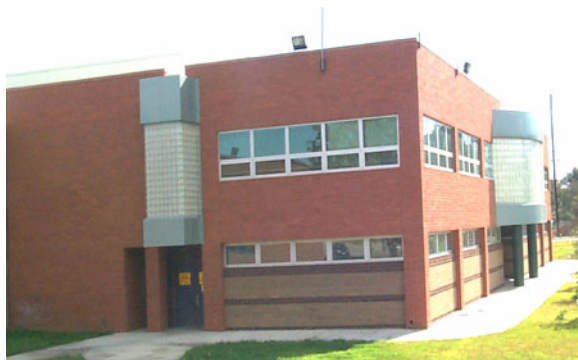
Figure E-46 Modern reinforced brick masonry.

Reinforced masonry buildings are mostly low-rise structures with perimeter bearing walls, often with wood diaphragms (RM1 buildings) although precast concrete is sometimes used (RM2 buildings). Floor and roof assemblies usually consist of timber joists and beams, glued-laminated beams, or light steel joists. The bearing walls consist of grouted and reinforced hollow or solid masonry units. Interior supports, if any, are often wood or steel columns, wood stud frames, or masonry walls. Occupancy varies from small commercial buildings to residential and industrial buildings. Generally, they are less than five stories in height although many taller masonry buildings exist. Reinforced masonry structures are usually basically rectangular structures (See Figure E-46).

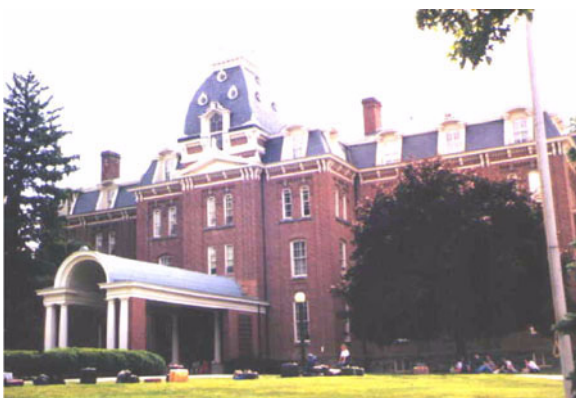
Figure E-50 East coast URM bearing-wall building.

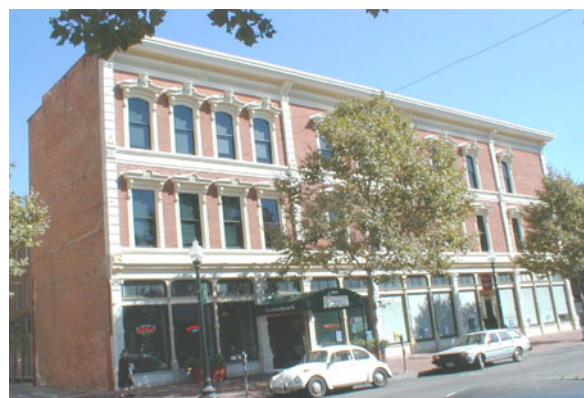
Figure E-51 West coast URM bearing-wall building.

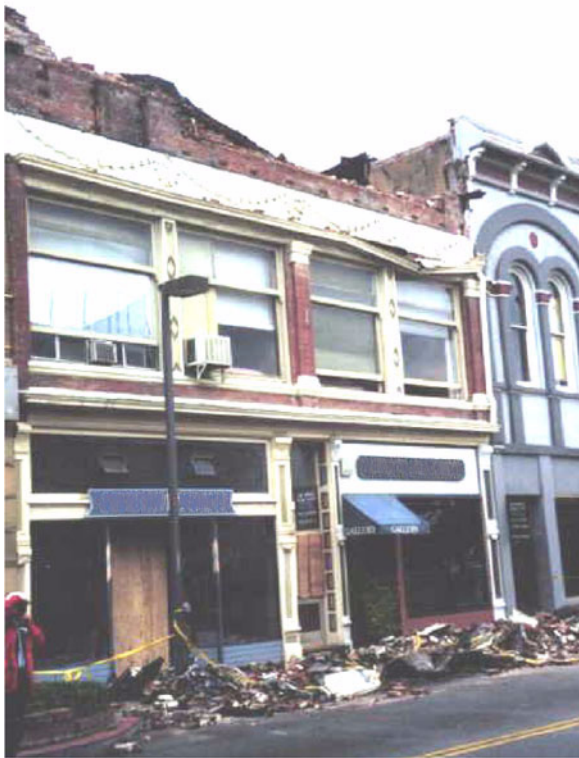
Figure E-53 Parapet failure leaving an uneven roof line, due to inadequate anchorage, 1989 Loma Prieta earthquake.

1. **Insufficient Anchorage**—Because the walls, parapets, and cornices are not positively anchored to the floors, they tend to fall out. The collapse of bearing walls can lead to major building collapses. Some of these buildings have anchors as a part of the original construction or as a rehabilitation. These older anchors exhibit questionable performance. (See Figure E-53 for parapet damage.)

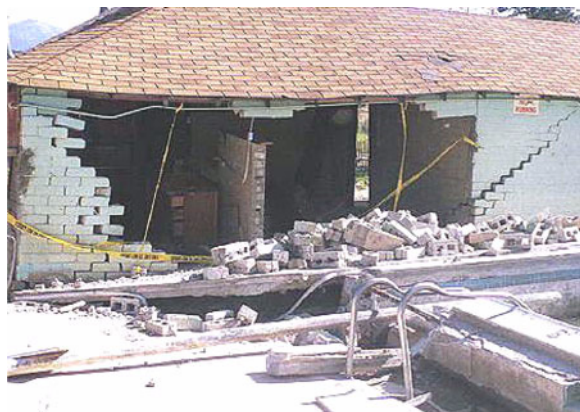
Figure E-54 Damaged URM building, 1992 Big Bear earthquake.

3. **Low Shear Resistance**—The mortar used in these older buildings was often made of lime and sand, with little or no cement, and had very little shear strength. The bearing walls will be heavily damaged and collapse under large loads. (See Figure E-54)

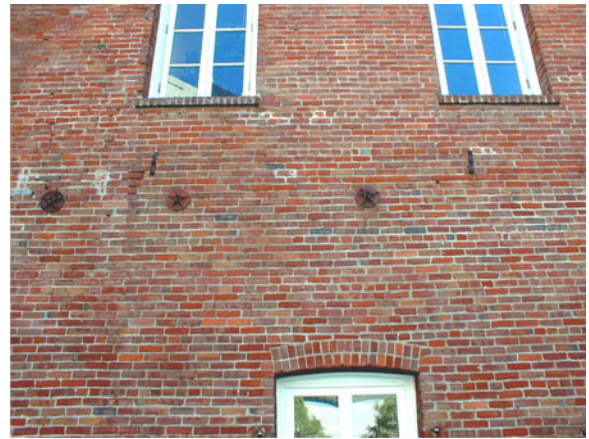
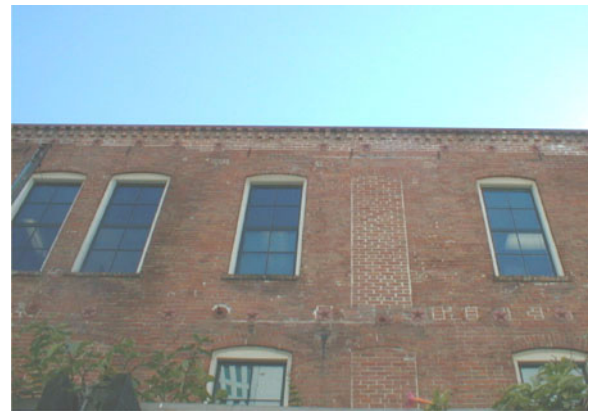
Figure E-55 Upper: Two existing anchors above three new wall anchors at floor line using decorative washer plates. Lower: Rehabilitation techniques include closely spaced anchors at floor and roof levels.

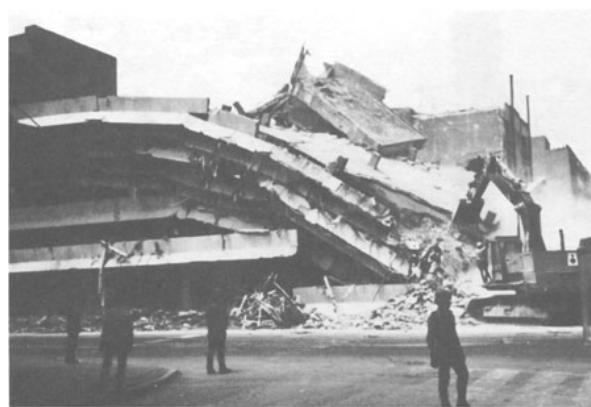
Figure F-5 Mid-rise building collapse, 1985 Mexico City earthquake.

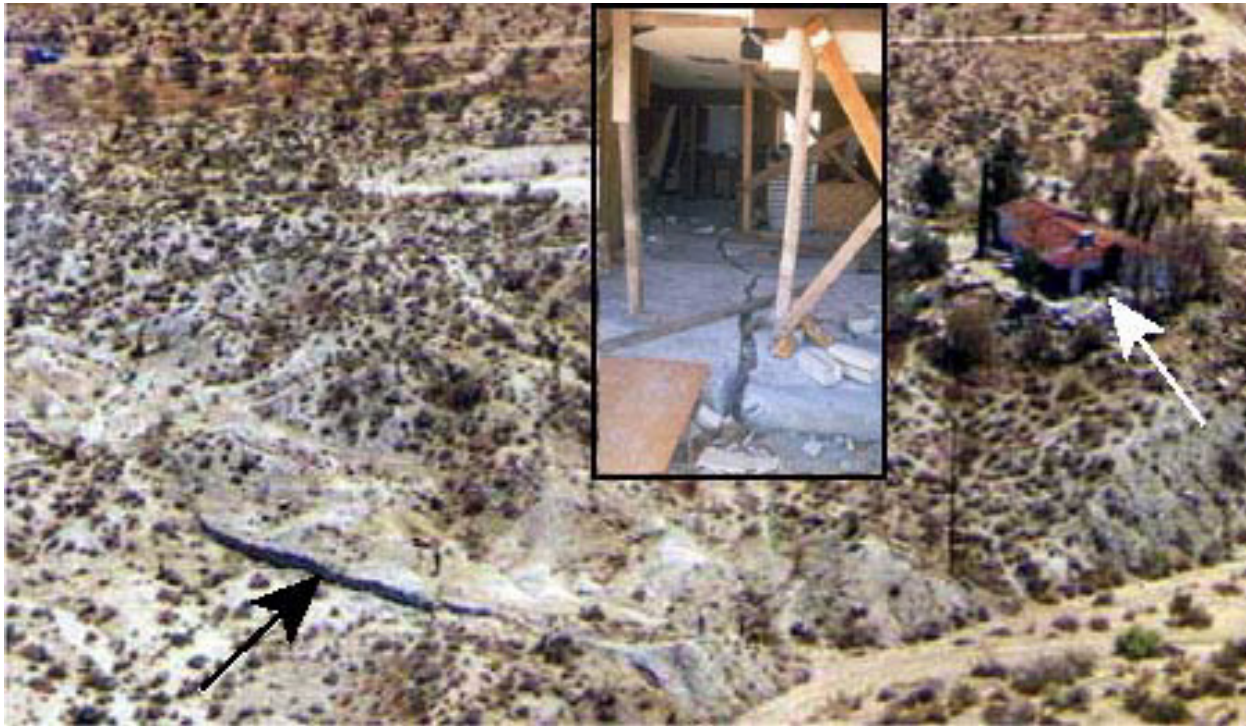
Figure F-6 Near-field effects, 1992 Landers earthquake, showing house (white arrow) close to surface faulting (black arrow); the insert shows a house interior.

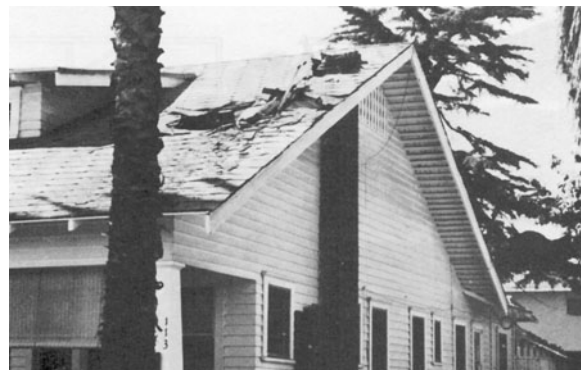
Figure F-7 Collapsed chimney with damaged roof, 1987 Whittier Narrows earthquake.

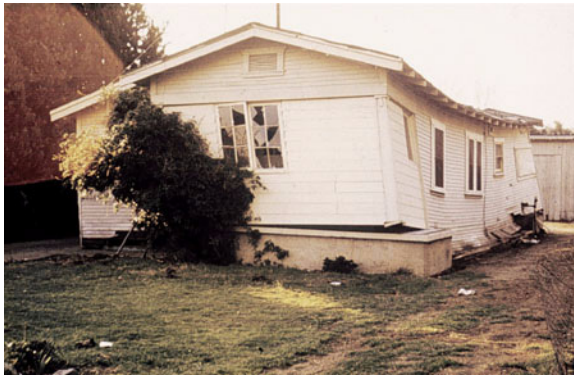
Figure F-8 House that slid off foundation, 1994 Northridge earthquake.

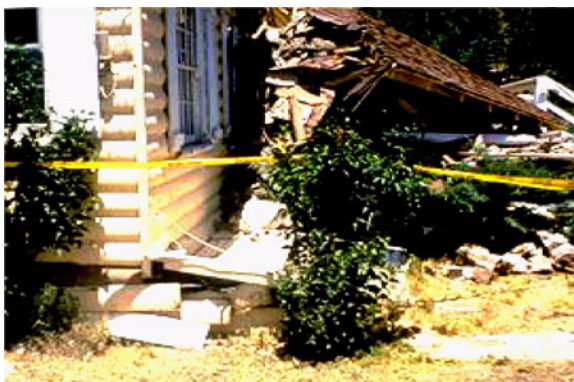
Figure F-9 Collapsed cripple stud walls dropped this house to the ground, 1992 Landers and Big Bear earthquakes.

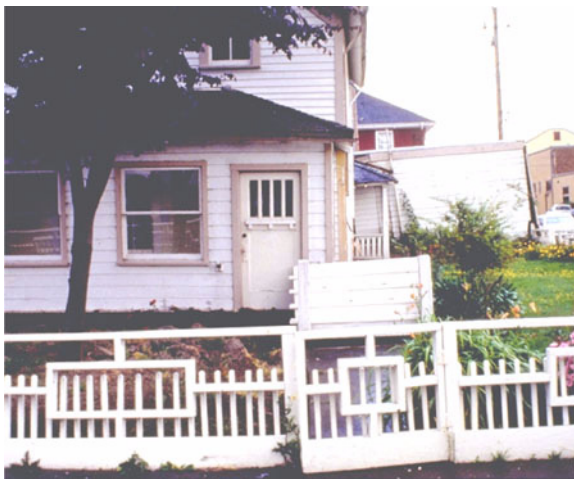
Figure F-10 This house has settled to the ground due to collapse of its post and pier foundation.
